Descent Below Visual Glidepath and Impact With Seawall  
Asiana Airlines Flight 214  
Boeing 777-200ER, HL7742  
San Francisco, California  
July 6, 2013

**Accident Report**

NTSB/AAR-14/01  
PB2014-105984

**National  
Transportation  
Safety Board**

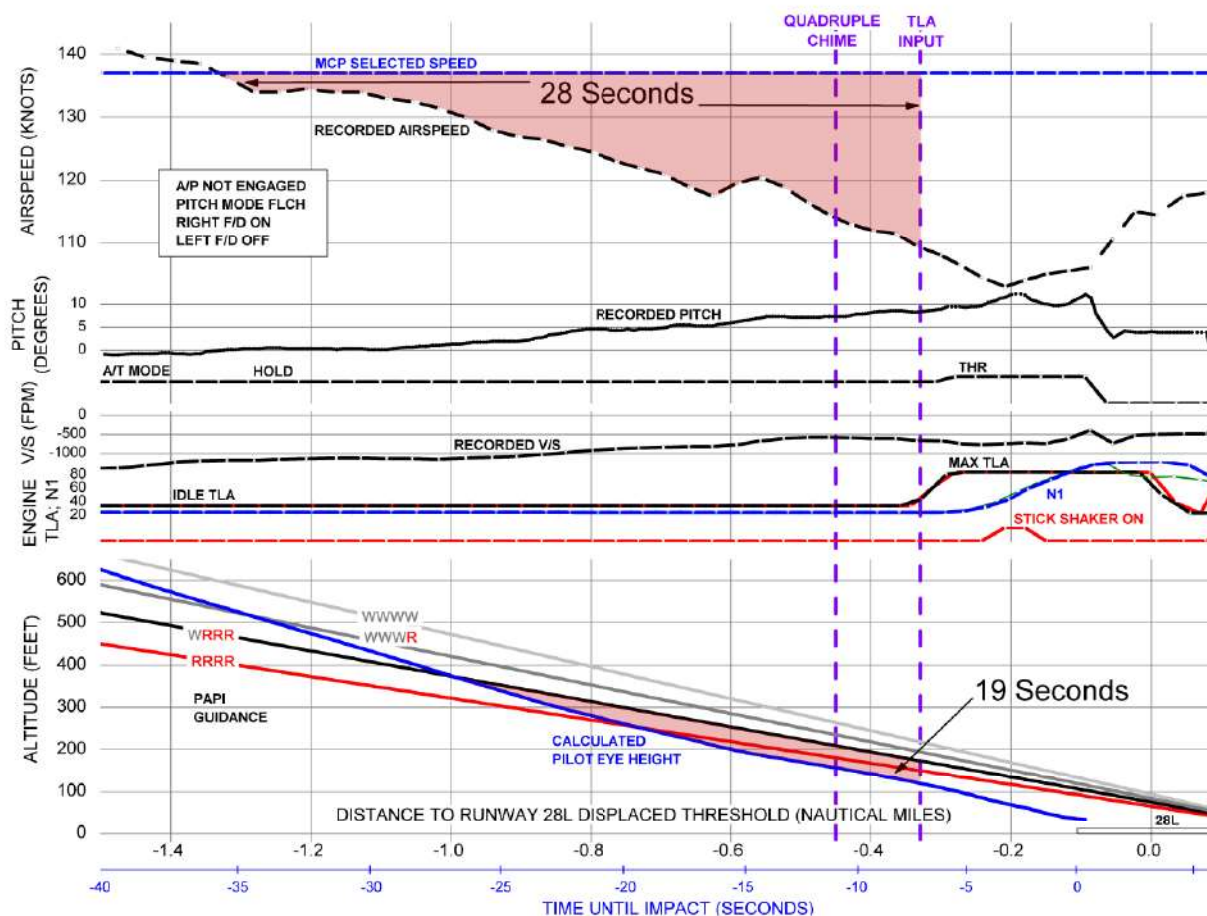
Figure 4. Profile view of the last 40 seconds of flight 214.

At 1127:14.8, the airplane was about 1.3 nm from the runway when it descended through 500 ft RA at an airspeed of about 137 knots with a descent rate of about 1,200 fpm. As shown in figure 4, which depicts a profile view of the last 40 seconds of the flight, the PAPI indication was three white lights and one red light—a slightly above glidepath indication—when the airplane descended through 500 ft RA. The thrust levers were at the idle position, and the engines’  $N_1$  speeds<sup>21</sup> were about 24%. At 1127:15.5, an electronic voice<sup>22</sup> announced “five hundred,” and about 1 second later, the PF called out “landing checklist.”

At 1127:23.3, the airplane’s airspeed dropped below 132 knots ( $V_{ref}$ ). At 1127:24.1, the airplane was about 1 nm from the runway at 331 ft RA, the airspeed was about 130 knots, the descent rate was about 1,000 fpm, and the PAPI indication changed to one white light and three red lights, showing the airplane’s slightly below-glidepath position. Over the next 5 seconds, the airplane’s pitch attitude increased from about 2° to 4° nose up, where it remained for about 3 seconds. At 1127:31.0, the airplane was about 0.7 nm from the runway at 219 ft RA, the airspeed was about 122 knots, the descent rate was about 900 fpm, and the PAPI indication changed to four red lights, showing the airplane’s significantly below-glidepath position. Over the next 5 seconds, the airplane’s pitch attitude increased to about 7° nose up, where it remained for about 3 seconds before continuing to increase.

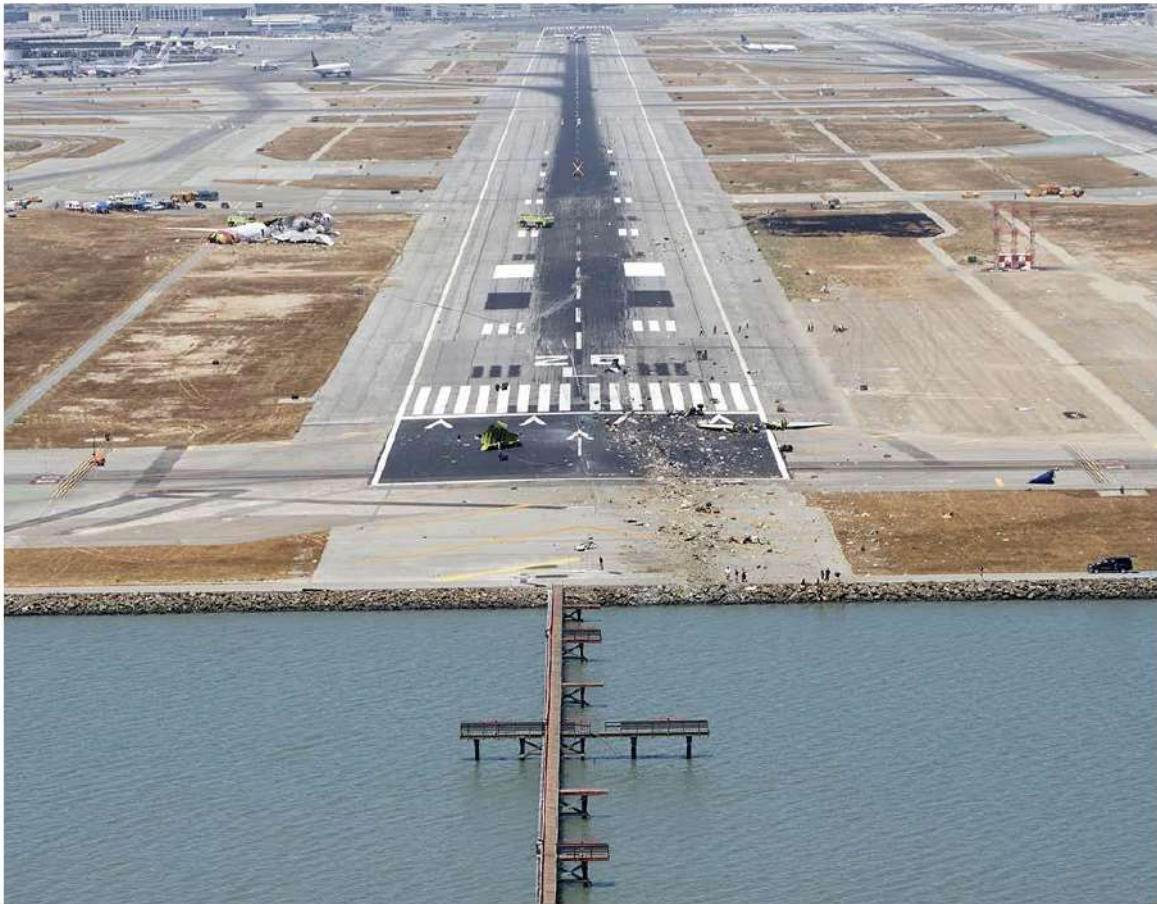
Figure 5. Aerial view of the flight 214 wreckage.

Video from airport surveillance cameras showed that following the initial impact, the tail of the airplane separated, the airplane slid along the runway, and the rear of the fuselage lifted up, tilting the airplane into about a 30° nose-down angle. The airplane pivoted counterclockwise about 330° before impacting a second time and coming to rest off the left side of the runway, about 2,400 ft from the initial seawall impact point. The airplane came to a stop about 1128:06.<sup>26</sup> Figure 5 is an aerial view of the approach end of runway 28L and the location of the wreckage. (See sections 1.15.3 and 1.15.4 for information about the evacuation and emergency response, respectively.)

The airplane was destroyed by the impact forces and postcrash fire.
